CHARACTERIZATION OF METALS MELTING DISCS
SKYLAB EXPERIMENT M551

Robert E. Monroe

BATTELLE COLUMBUS LABORATORIES
Columbus, Ohio 43201

December 4, 1973

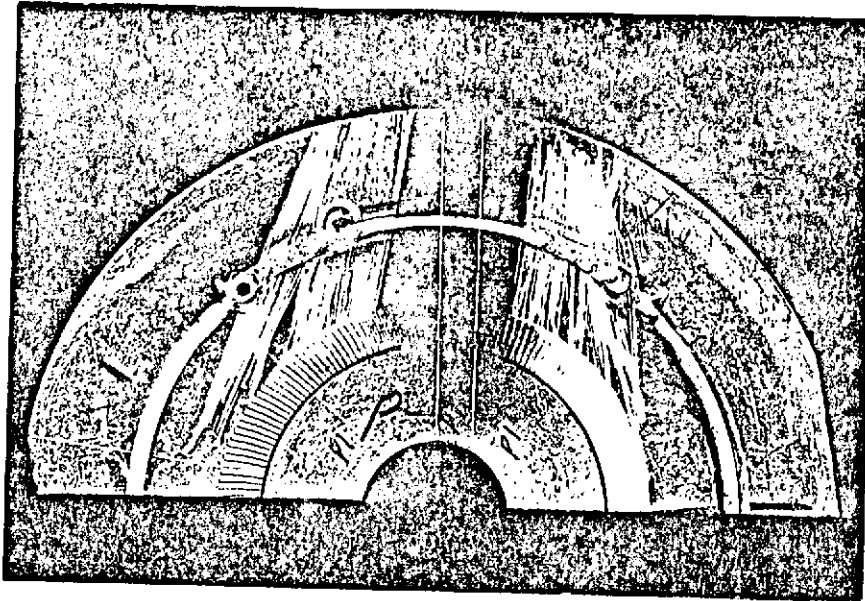
No defects were noted in the radiograph except crater cracks at the weld stops and dwells. Figure A-2 shows the appearance of this disc as received. The black area is a molybdenum spray coating used for a tracer. A section through the weld zone in the area of the tracer is shown in Figure A-3. No adverse effects of the tracer on the weld region were noted in this section.

FIGURE A-2. FRONT SURFACE OF P-1

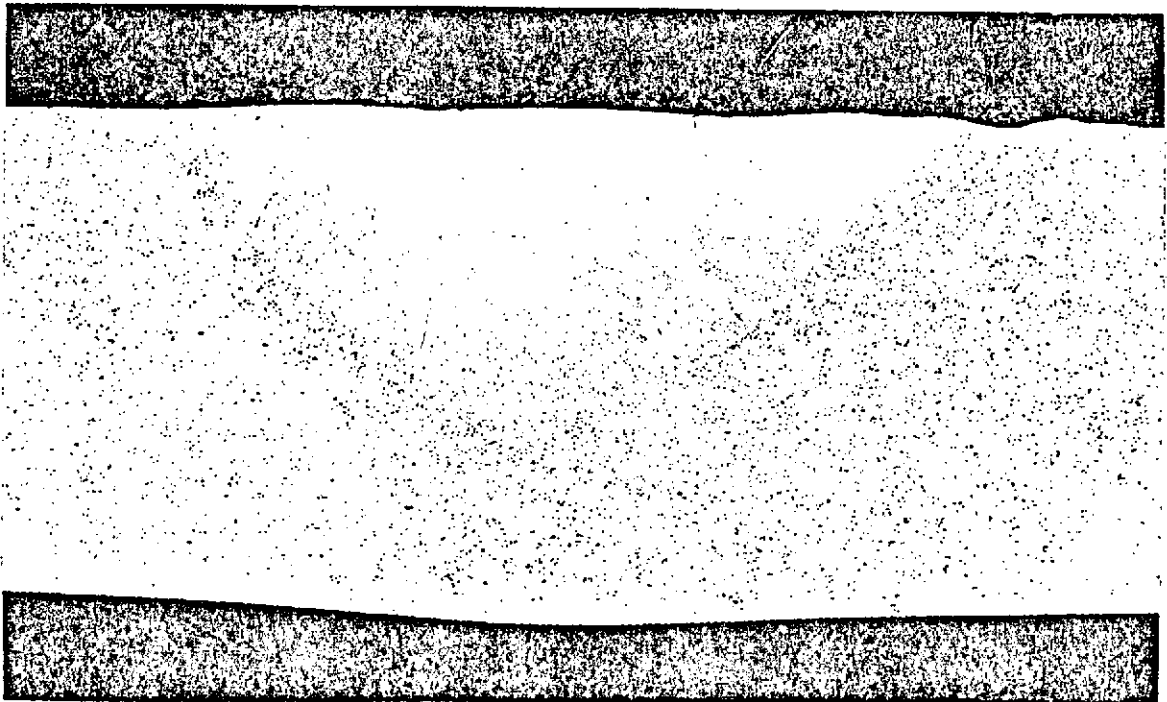
FIGURE A-3. SECTION P-1 AT TRACER REGION

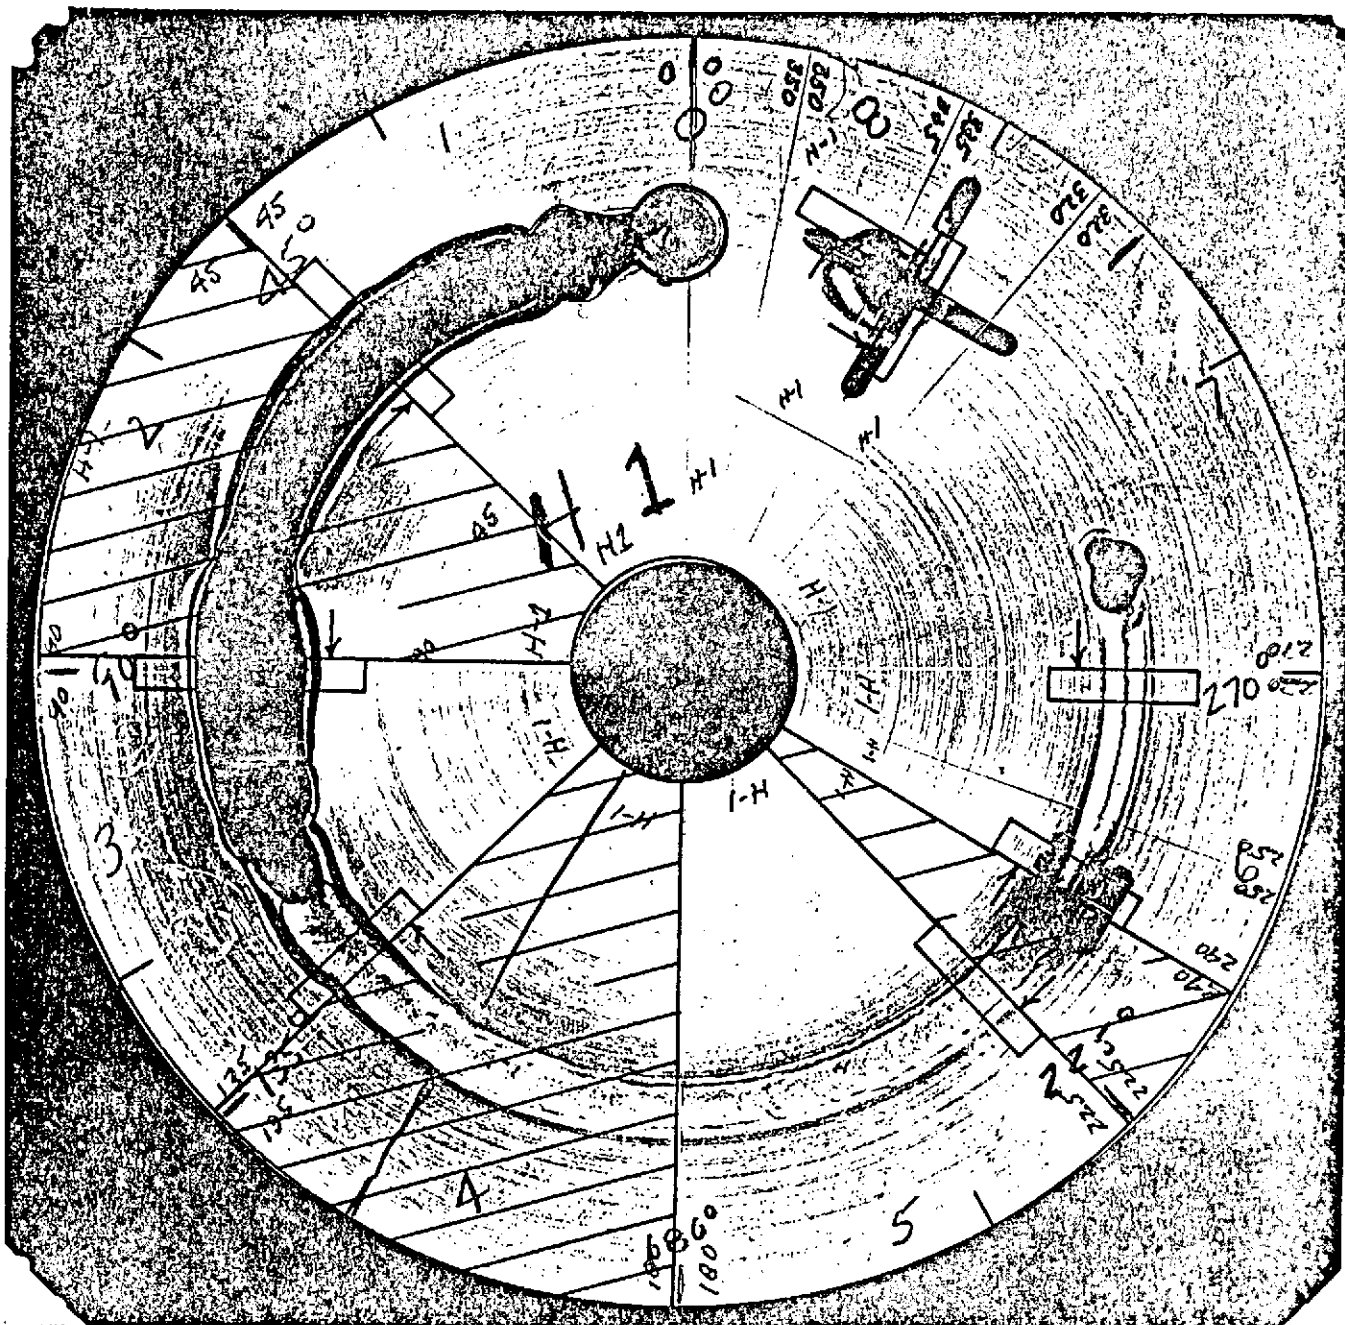
The radiograph showed longitudinal weld cracks near the weld start (125° to 135°), and near the molybdenum tracer (225° to 235°). Cracks in the dwell crater also were apparent. All of these cracks also were visible on the weld surface. Figure A-4 shows the front surface of Disc H-1. The rectangular cutouts were examined at Battelle. The cross hatch wedge sections were sent to MSFC for examination.

FIGURE A-4. FRONT SURFACE H-1

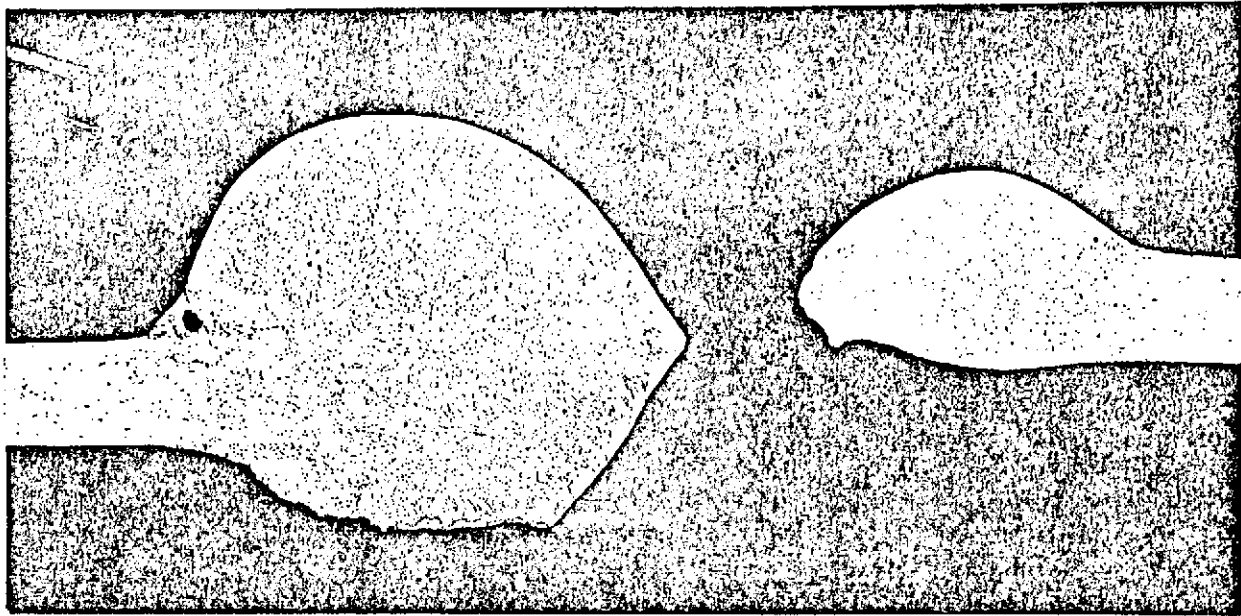
Figures A-5 through A-10 show the appearance and microstructural details in the cut region. Several areas on the cut surfaces indicate the presence of a contaminant or reaction zone. This has probably come from material vaporized from the surface under the weld disc. The very wide cut that resulted in this disc is

FIGURE A-5. SECTION THROUGH CUT REGION -H-1

indicative of an electron-beam power level favoring excessive penetration.

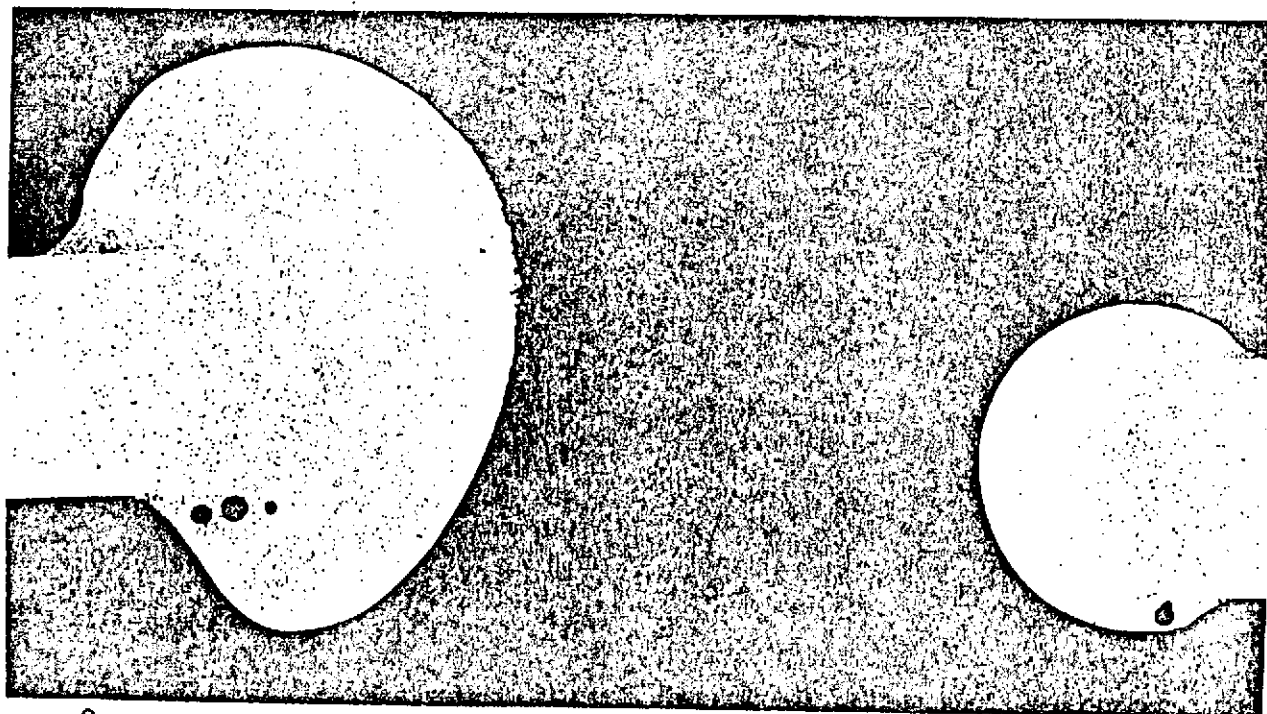
FIGURE A-9. SECTION THROUGH RAMP REGION -H-1

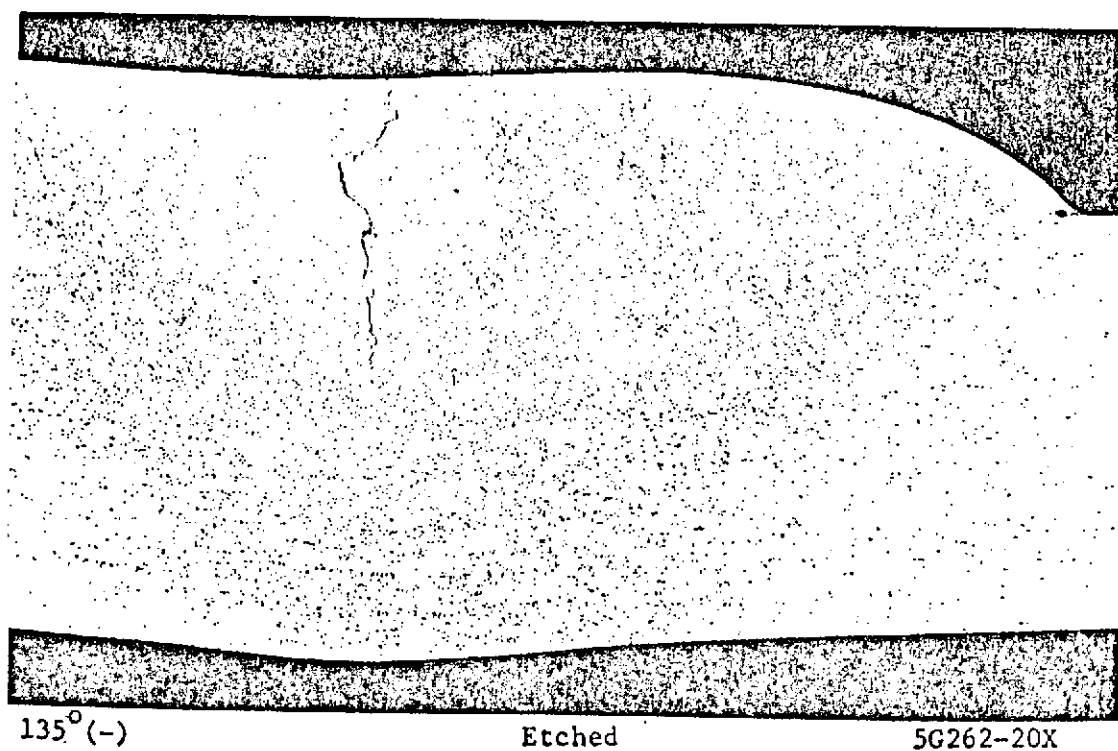
FIGURE A-11. SECTION THROUGH CRACK NEAR WELD START

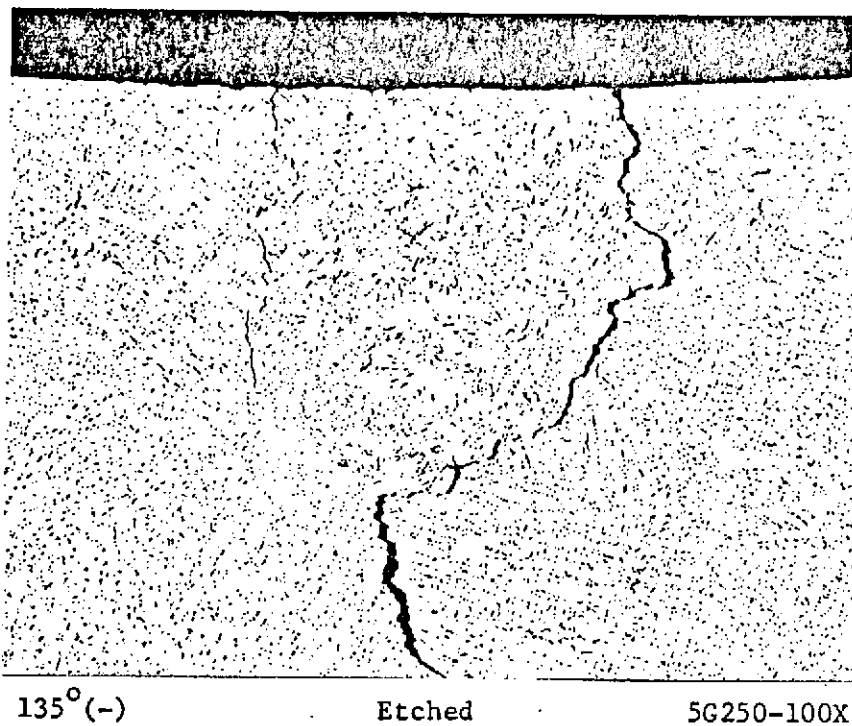
FIGURE A-12. ENLARGEMENT OF LONGITUDINAL CRACK
AT WELD START - H-1

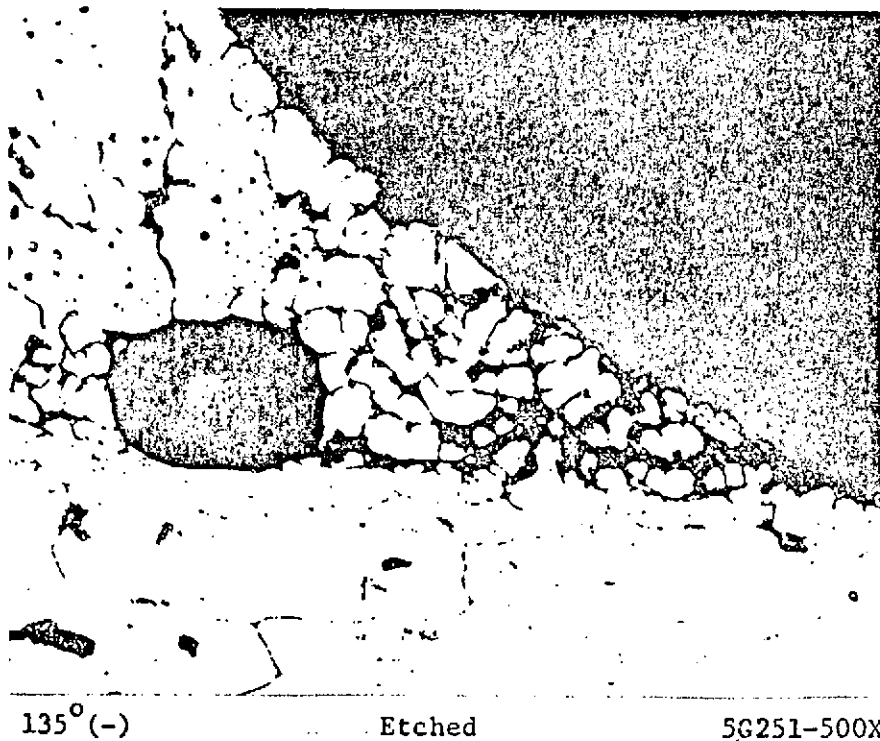
FIGURE A-13. PORE AT INSIDE EDGE OF WELD - H-1

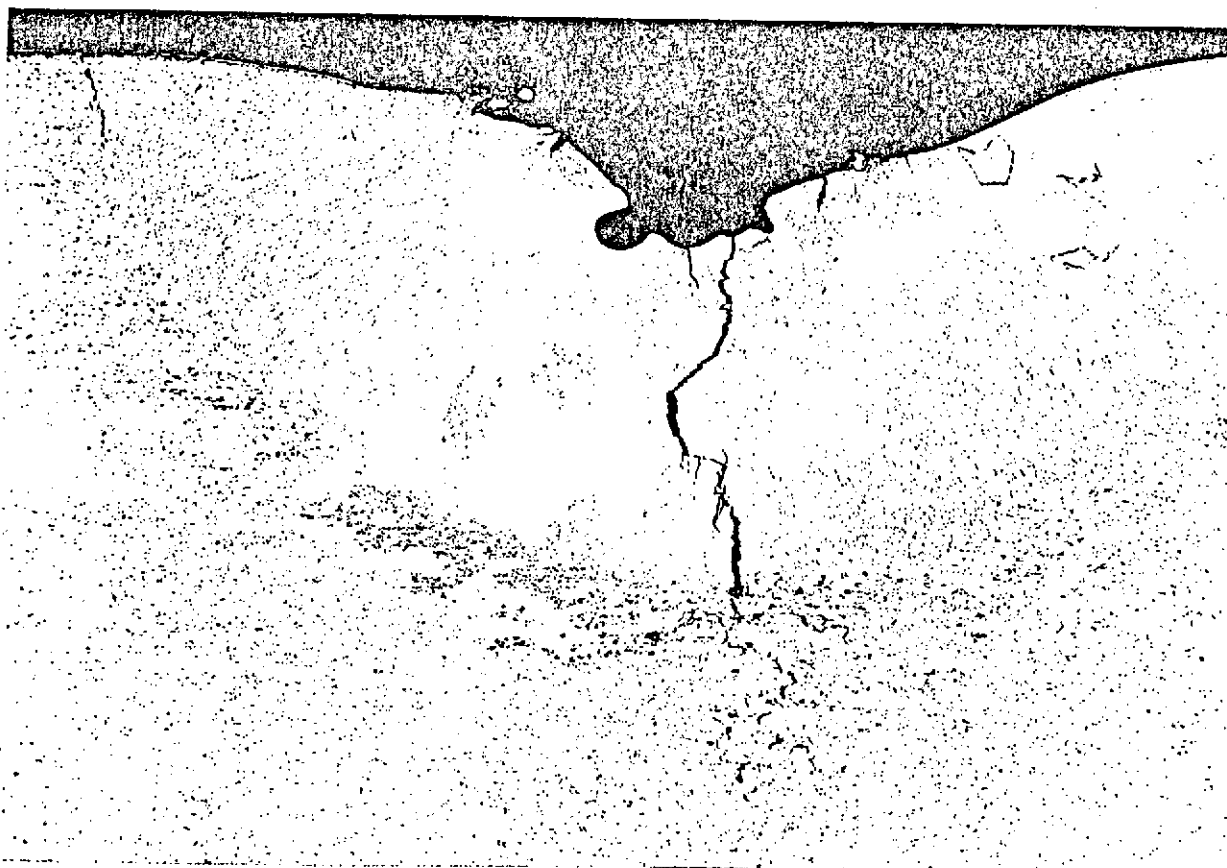
FIGURE A-19. SECTION THROUGH DWELL REGION - H-1

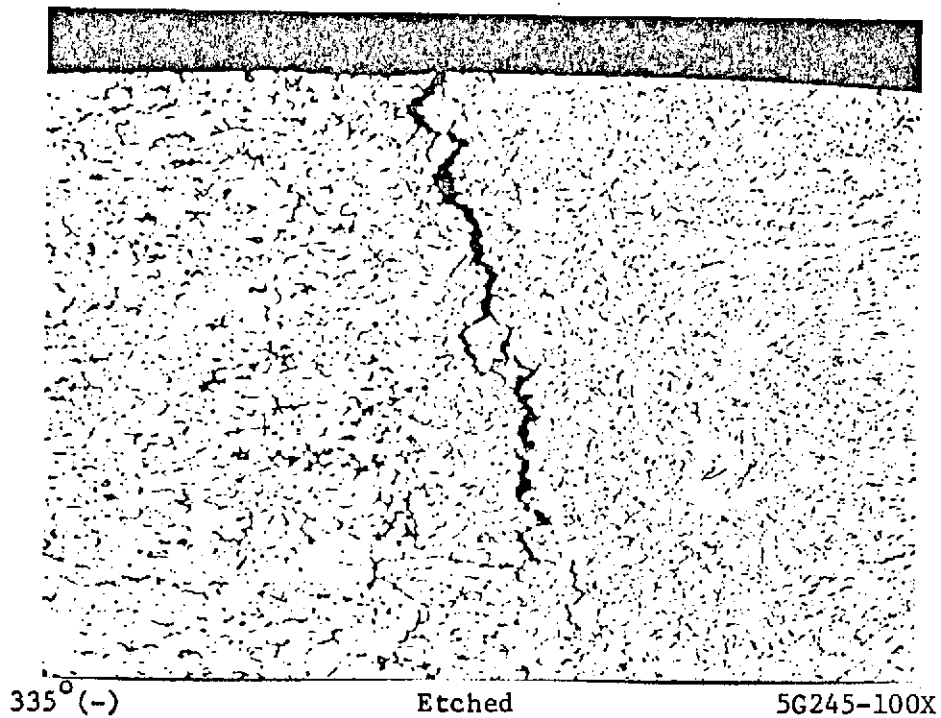
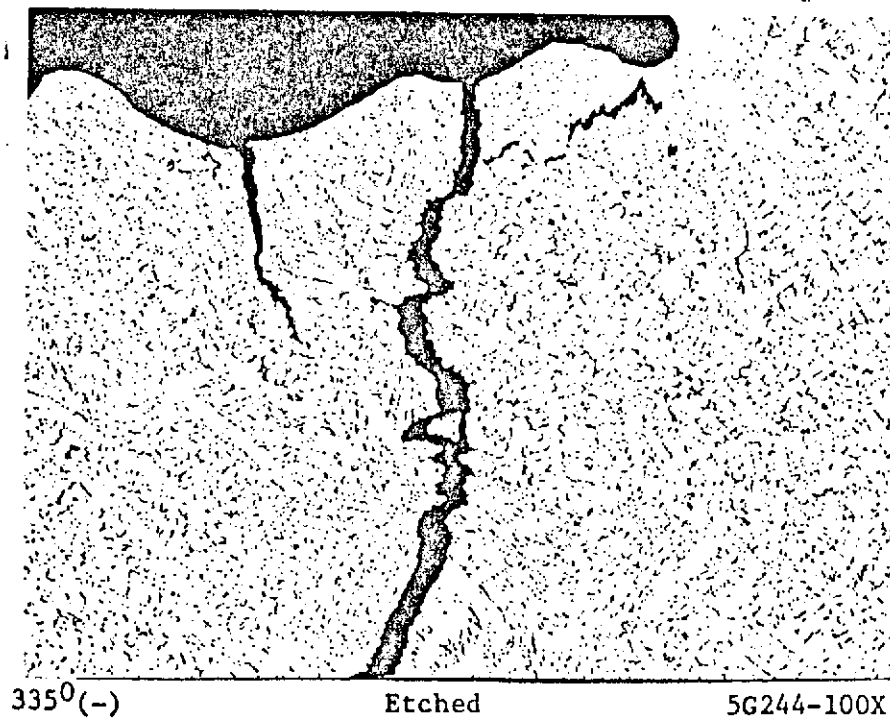
a. Crack near left edge in Figure A-19

b. Main crack near center in Figure A-19

FIGURE A-20. CRACKS IN DWELL REGION- H-1

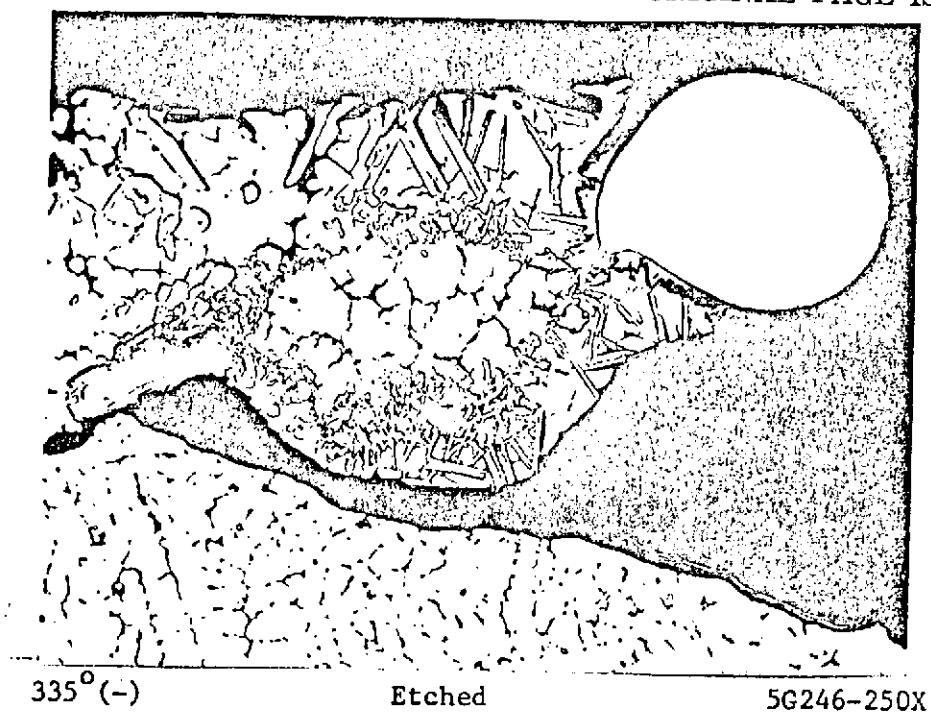
a. Near Left center in Figure A-19

FIGURE A-21. MOLYBDENUM TRACES ON SURFACES OF
DWELL REGION- H-1

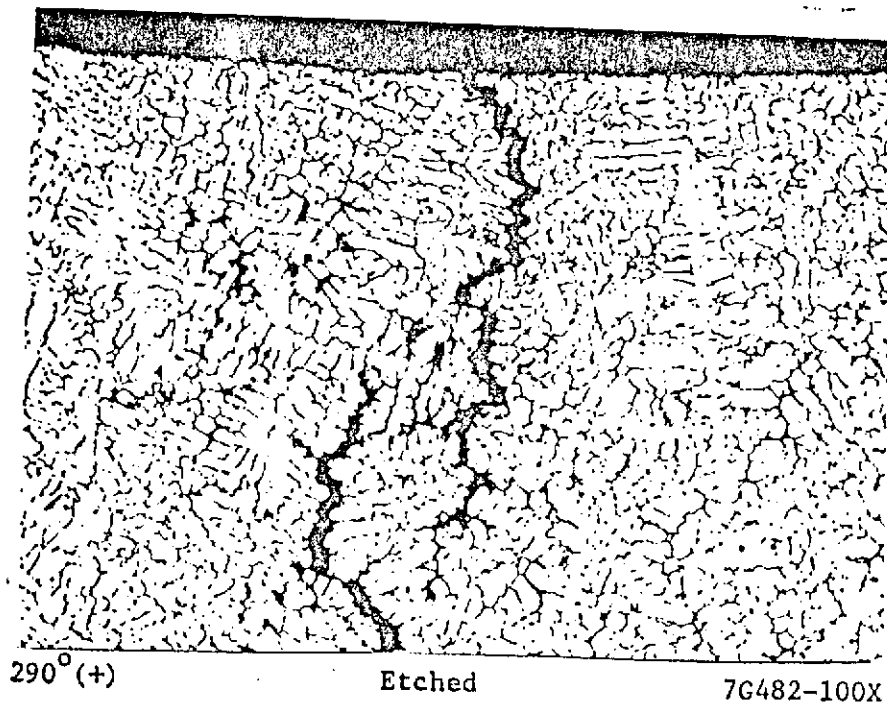
FIGURE A-30. SECTION THROUGH CRACK
IN DWELL REGION - S/N-124

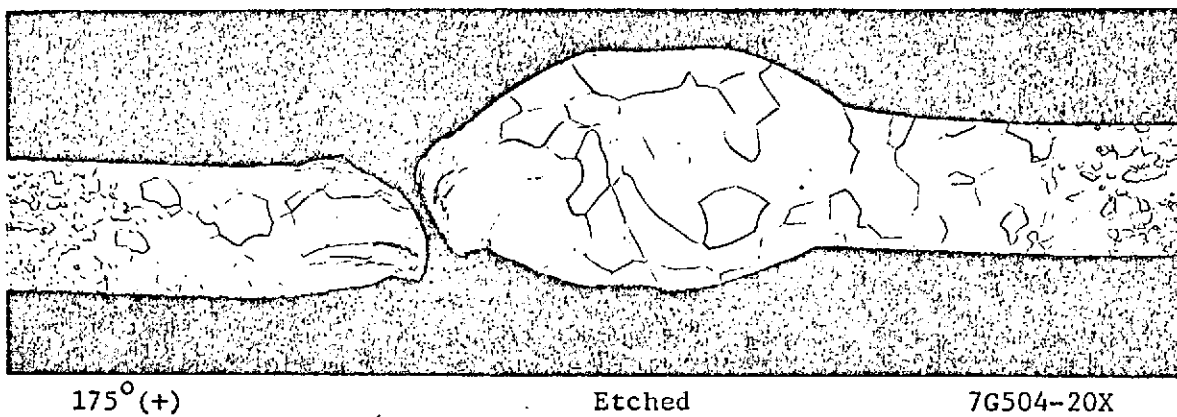
FIGURE A-60. SECTION THROUGH BRIDGE BROKEN
IN CUTTING S/N 143
